National Register of Historic Places  
Inventory—Nomination Form

and or common West 67th Street Artists' Colony Historic District

street & number 1-39 and 40-50 West 67th Street

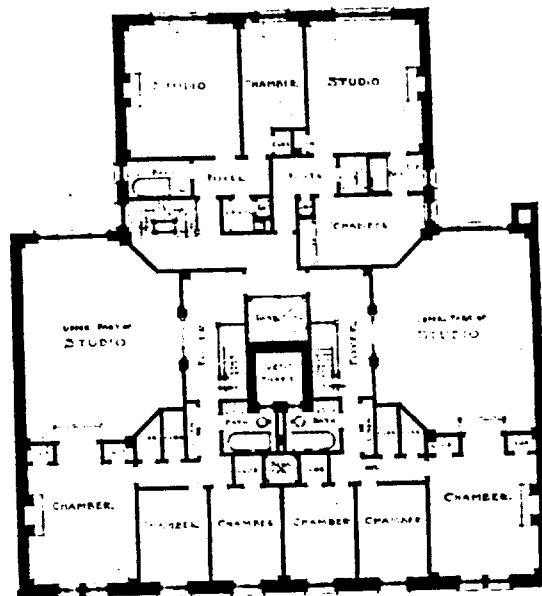
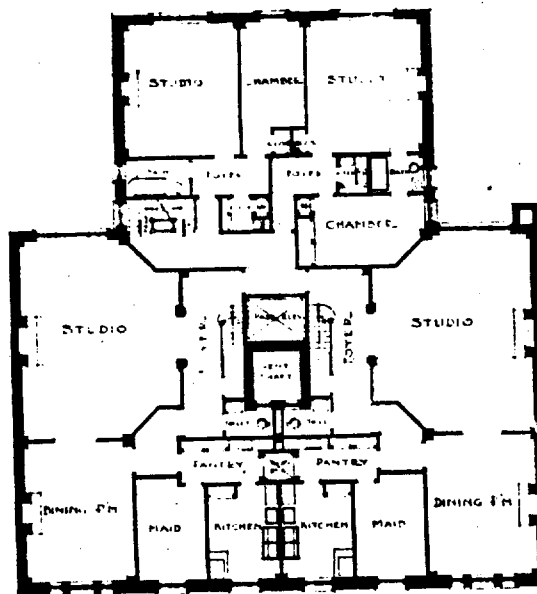
Plate 5

THIRD FLOOR PLAN.

SECOND FLOOR PLAN.

27 West 67th Street Typical Duplex Floor Plan  
 From: "The Development of Duplex Apartments.--  
 II. Studio Type," by Elisha Harris Janes.  
The Brickbuilder, 21(July 1912) 183.
